NASA Technical Memorandum 104532
AIAA-91-2123

Microanalysis of Extended-Test Xenon Hollow Cathodes

MICROANALYSES OF EXTENDED-TEST XENON HOLLOW CATHODES

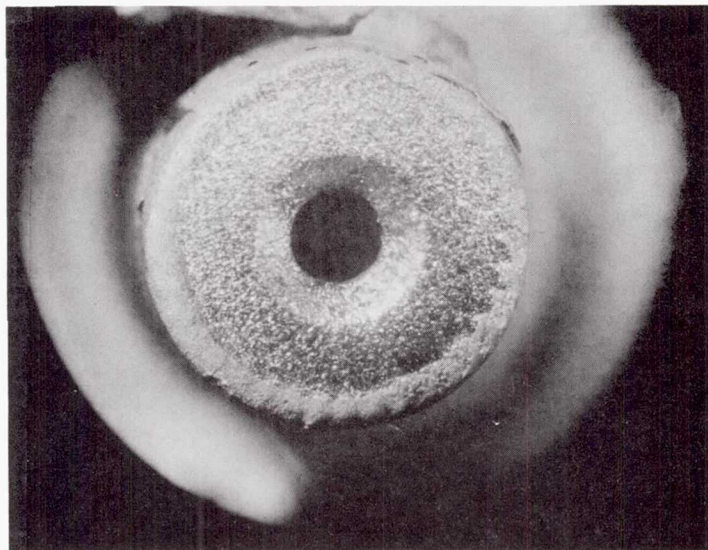
(b) After Testing

The external surface conditions of the cathodes were examined prior to and after all the tests. For the first wear-test, cathode WT-I had not previously been used. The orifice plate showed machining marks and the electron-beam weld was clearly visible, as shown in the photograph in Figure 11(a). In addition, the edges of the chamfer were well-defined and the chamfer had the same smoothness as the plate surface. After the wear-test, the orifice plate was substantially roughened over its entire area, including the chamfer (Fig. 11(b)). The Ta foil thermocouple cover junction appeared severely eroded and heat-treated. Also, the downstream end of the cathode body tube had the appearance of being eroded up to the point of coverage by the swaged heater.

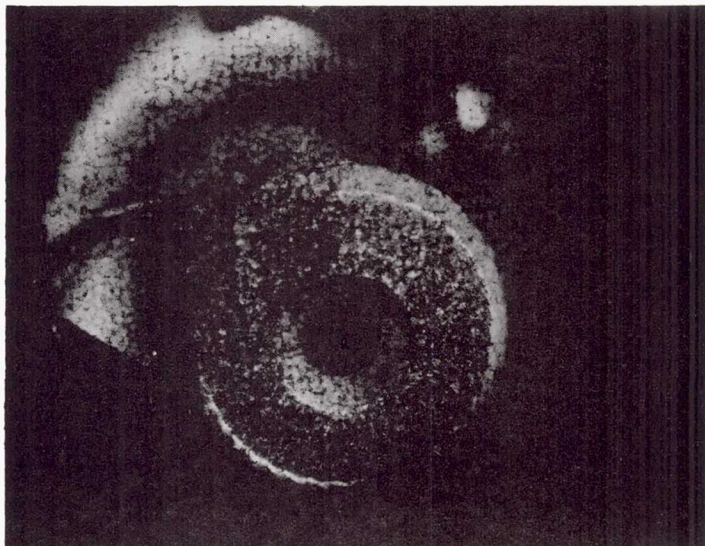
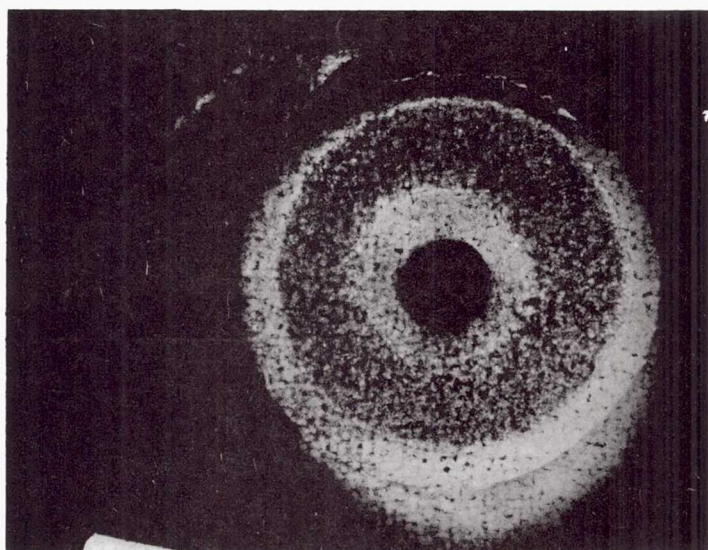
Figure 12. External surface of cathode WT-II orifice plate.

The initial condition of cathode WT-II shows in Fig. 12(a) the effects of 41 hours of discharge operation prior to the wear-test. The orifice plate was already eroded and exhibited the

roughened appearance on plate, chamfer, and e-beam weld surfaces. However, the orifice geometry had not been altered; the chamfer was straight and the orifice had the specified size and shape. The Ta foil cover over the thermocouple junction was undamaged. Post-test examination of the condition of the orifice plate showed no discernible change (see Fig. 12(b)). The cathode tube exhibited the same surface erosion observed on cathode WT-I and the Ta foil was sufficiently embrittled to flake off when a slight force was applied.

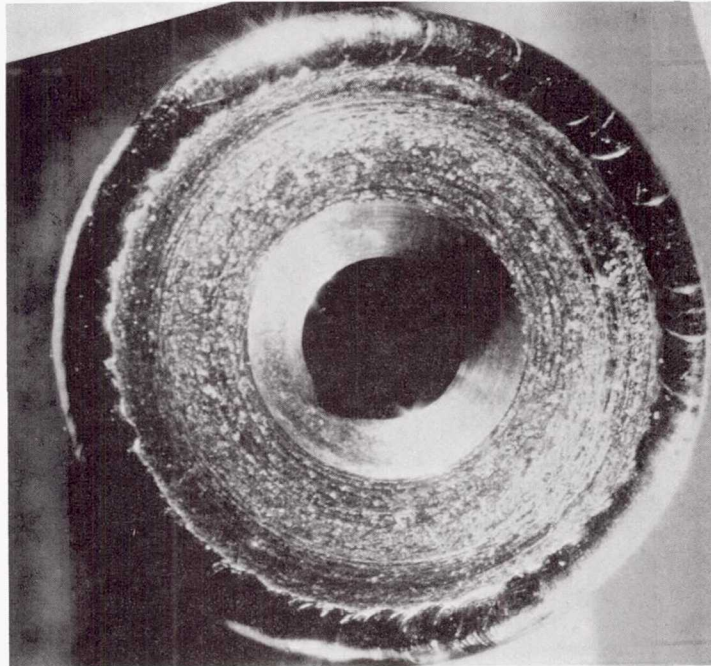
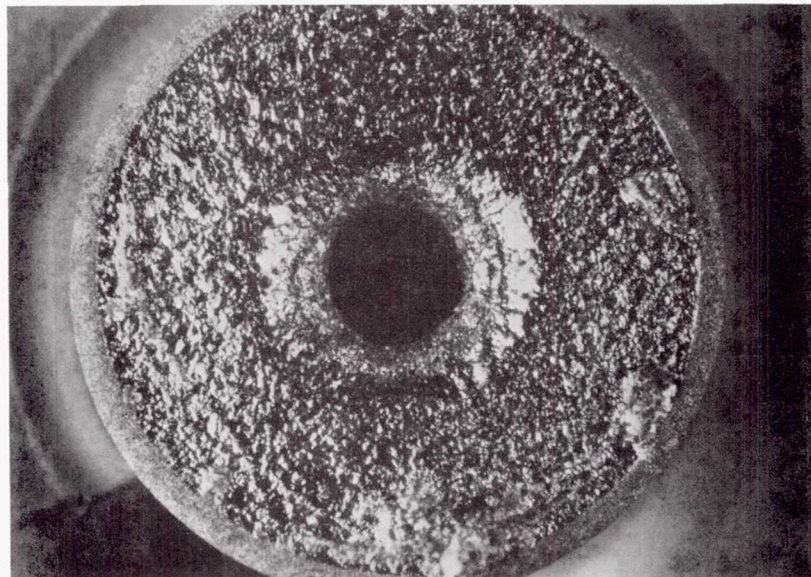
Figure 13. External surface of cathode TL-I orifice plate.

Prior to the life-test and the initial check-out period, both cathodes TL-I and TL-II were in pristine condition, as shown in Fig. 13(a) and 14(a). Post-test examination showed several changes which are shown in Fig. 13(b) and Fig. 14(b). Cathode TL-I experienced severe ion bombardment of the orifice and orifice plate. The surface had been roughened to the point of removing all pre-test features including the electron-beam weld structure. The chamfer on the orifice appeared to no longer be a smooth 45°, but very irregular and filled-in. In addition, the orifice, while not changing significantly in diameter, had an irregular geometry with one edge being opened up, possibly by erosion. There also appeared to be irregular metallic deposits on the orifice plate.

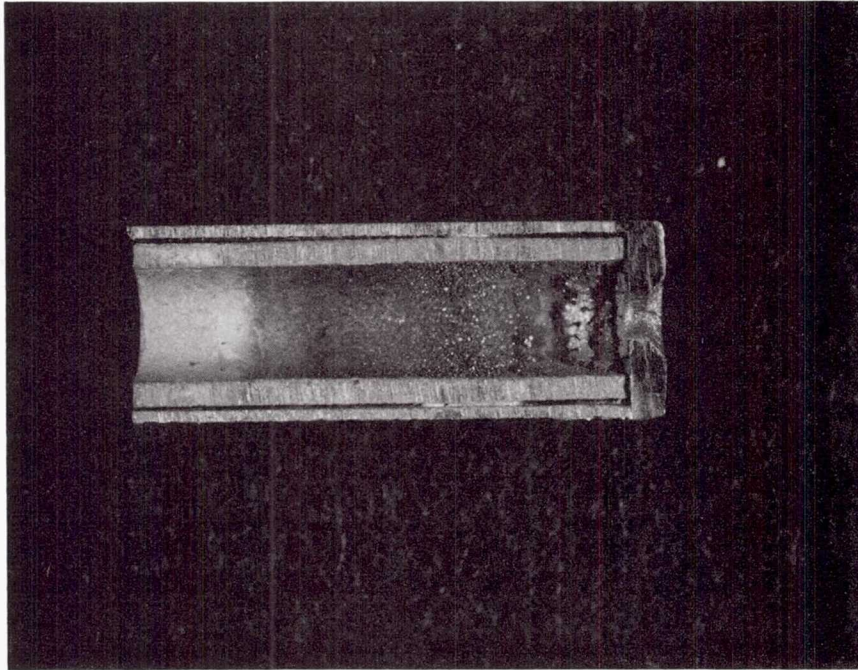
(a) WT-I Cathode

Inside cathode WT-I, the shape of the orifice chamfer and channel appeared intact. However, a large deposit of material was found at the downstream end of the insert and on the orifice plate, as shown in Fig. 15(a). The rest of the insert surface was divided up into three regions with decreasing degrees of roughness and different colors. The insert surface was slightly irregular, indicating material removal. There was also material visible between the insert outer wall and cathode body tube. This material may have been responsible for affixing the insert to the cathode body.

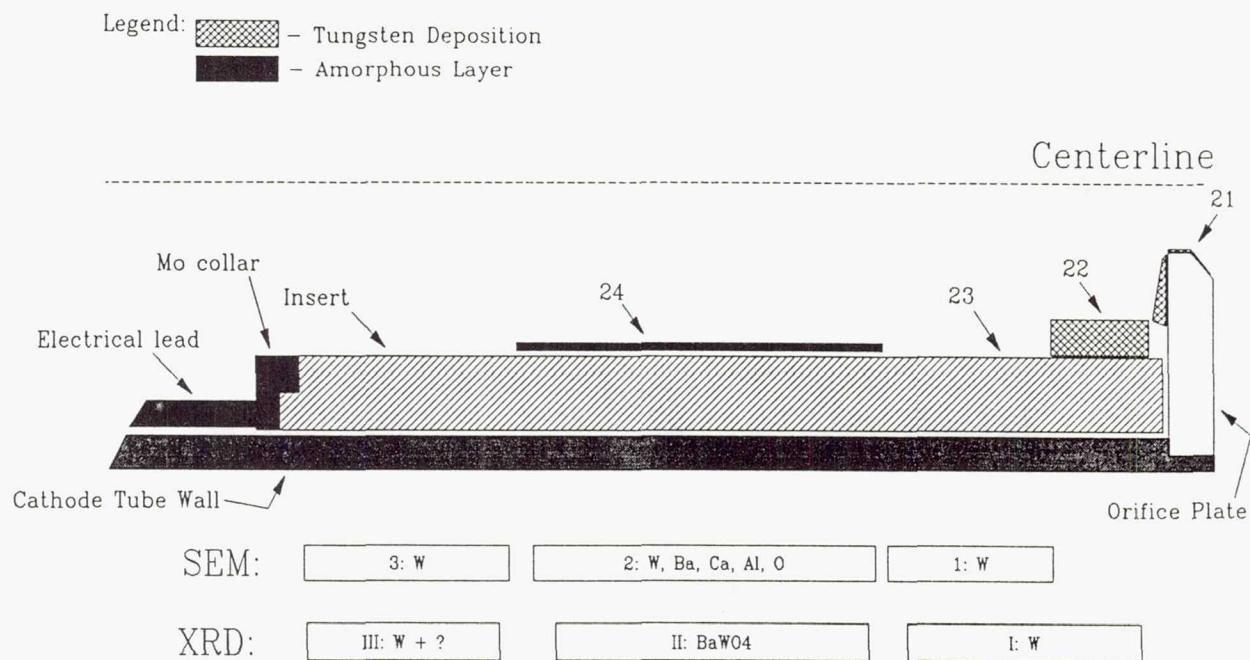
In cathode WT-I, the most prominent change found was material deposition, which occurred primarily in the downstream end of the cathode. The channel and chamfer of the orifice were clear of any obstruction, though the surface appeared to have some amount of deposition on it, as can be seen in the photograph in Fig. 21. There was a substantial tungsten deposition on the upstream side of the orifice. The deposition was roughly uniform around the orifice and had a diameter of approximately 2.8 mm.

Figure 17. Schematic of cathode WT-I cross-section with the observed phenomena summarized. Numbers locate the SEM photographs by figure number and the SEM and XRD bars list the elemental and molecular composition in respective regions.

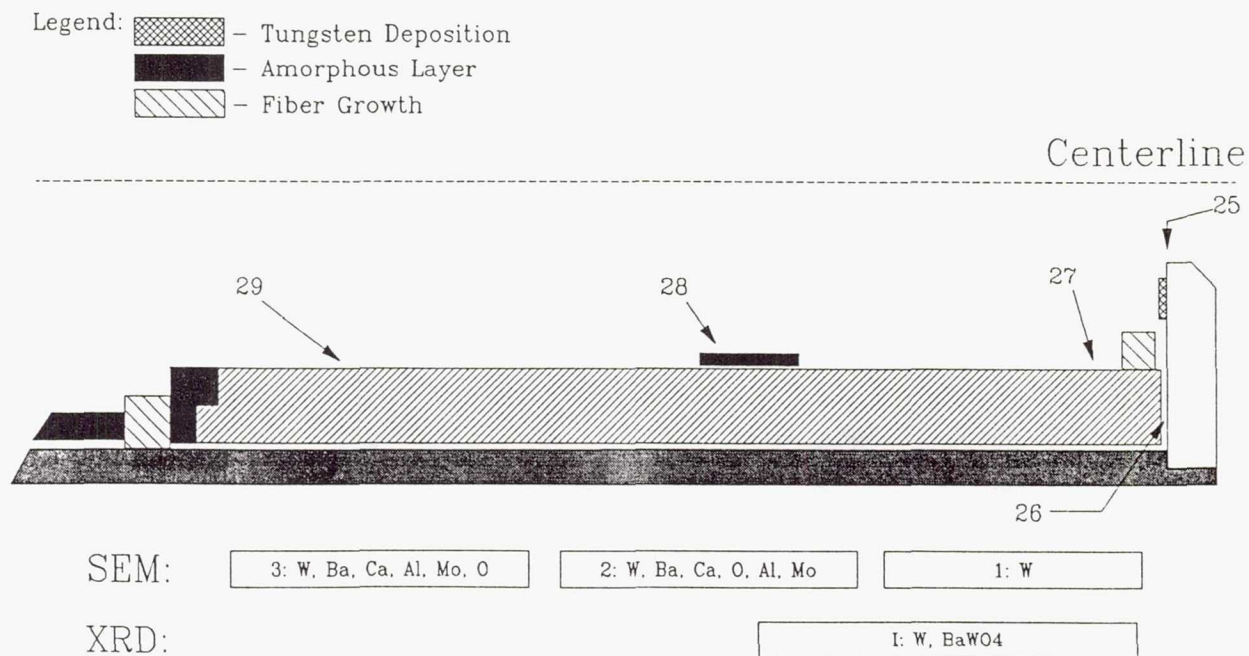
For cathode WT-II, the orifice plate and insert surfaces were observed to be in relatively good condition. The orifice appeared to be surrounded by a rough ring of deposited material, but it was difficult to distinguish the amount. Outside of this ring, some material had collected over the rest of the orifice plate in grain-like structures. The downstream end of the insert had a ring of crystal growths that stuck fiber-like out from the surface, as indicated in Fig. 18. These fibers appeared to be deposited metal and have very reflective surfaces. The ring was very narrow and had a distinct boundary with a region of very fine structure. This next region appeared to be uniformly covered with fibrous crystals, possibly of similar composition as the larger growths observed at the insert edge. Upstream of the fibrous growth, the remainder of the insert surface appeared uniform and without any distinct features, though different color striations were apparent. The molybdenum collar at the upstream insert end appeared clear of material deposition. Crystal growth was apparent in the gap between insert wall and cathode tube wall with some material extending further upstream of the moly collar. Later boroscope examination did not find this material as it was lost when the insert was found to be removable.

Figure 18. Schematic of cathode WT-II cross-section with the observed phenomena summarized.

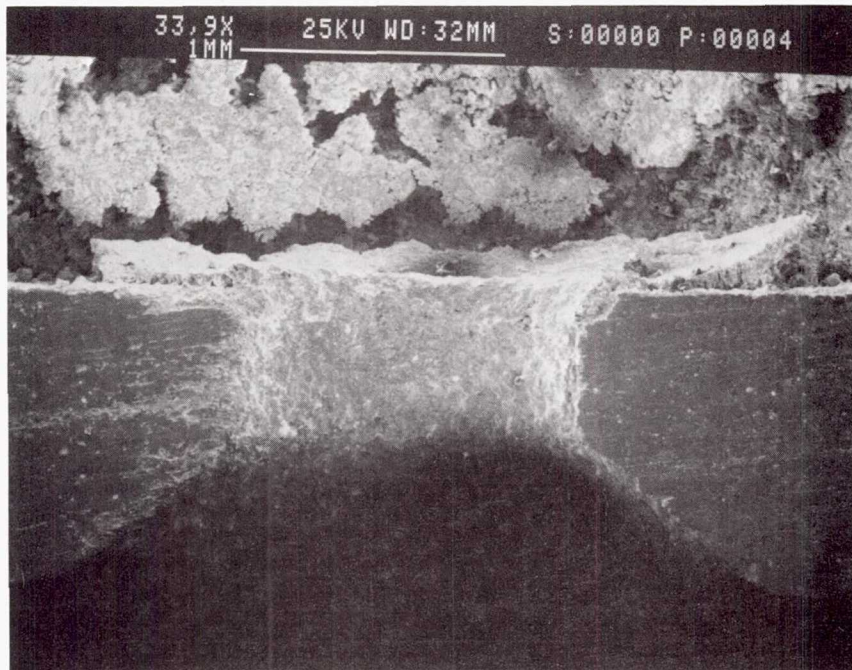
Figure 21. SE image of the orifice channel of cathode WT-I. Propellant flowed from top to bottom.

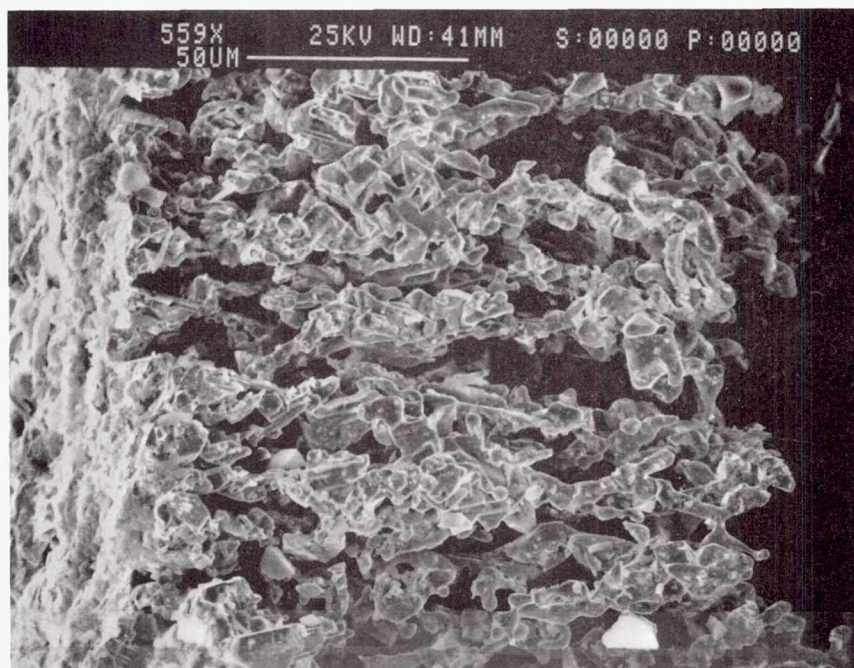
Figure 22. SE image of the tungsten deposition on the downstream end of cathode WT-I. The top of the deposition surface is at the left of the photograph.

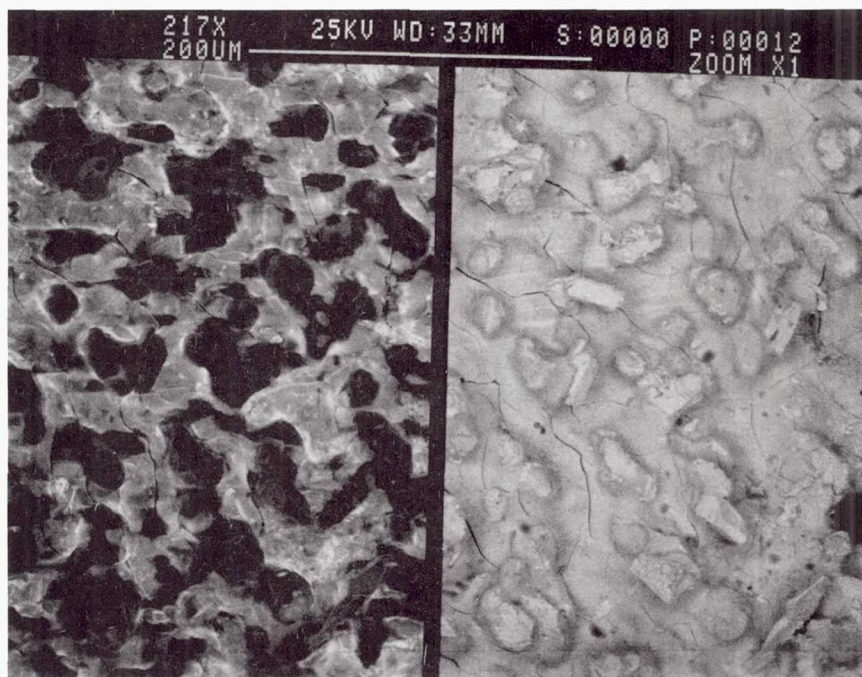
Figure 24. Nonconductive material on the surface of the third section of cathode WT-I insert, SE image on the left and BSE image on the right.

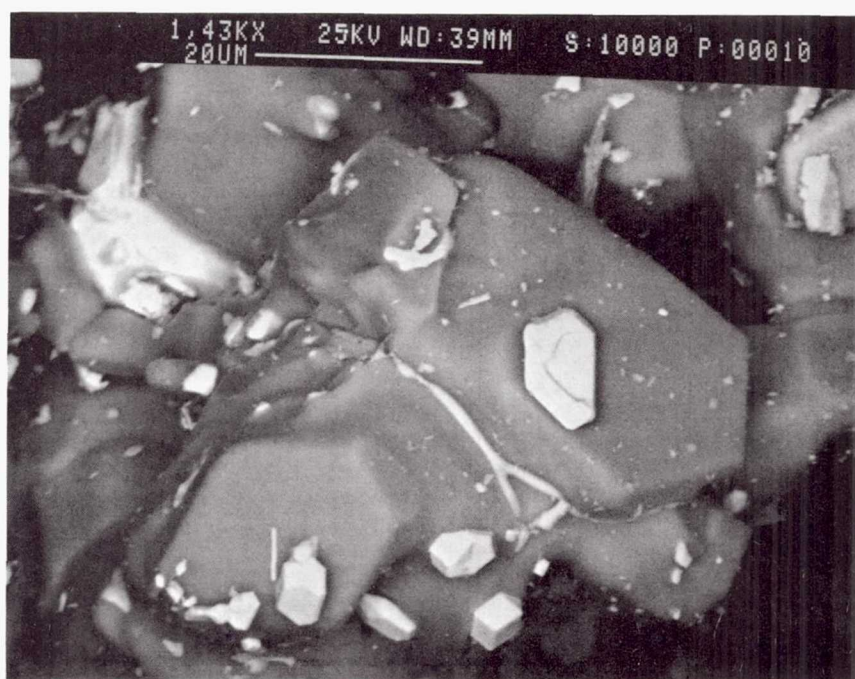
Figure 32. BSE image of coating composed of barium, aluminum, tungsten, and oxygen on the orifice plate in cathode TL-I.

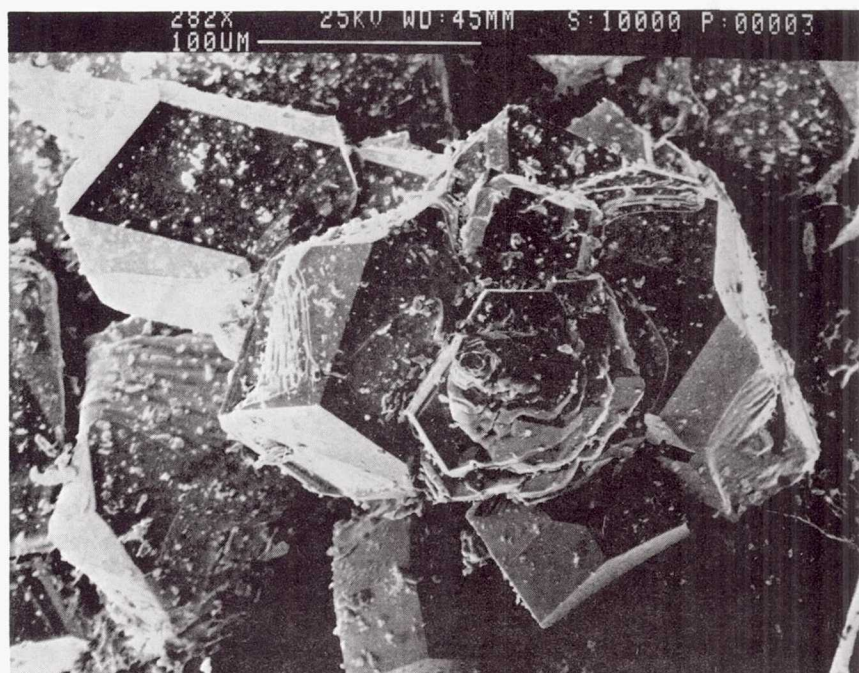
Figure 35. SE image of deposited material obtained from cathode **TL-I** during slicing.

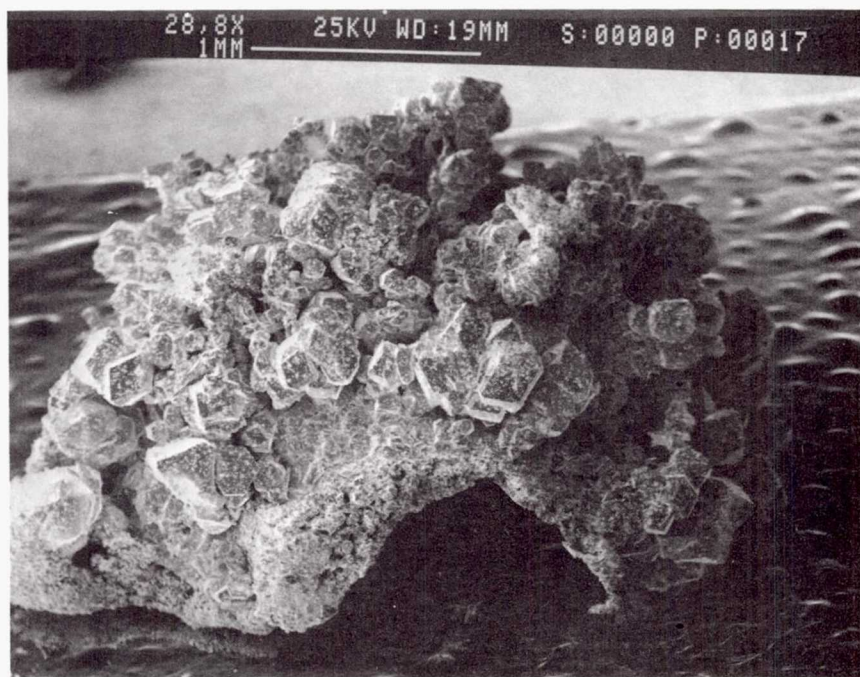
The interior of cathode TL-II is represented in Fig. 20 and had many of the same characteristics as cathode TL-I. The orifice was found to be blocked (visually) by a large metallic deposit. The material of this plug extended into the insert cavity as well as covered a substantial area of the orifice plate. However, the degree of physical blockage was unknown. The downstream insert surface area possessed several ridge-like features which were relatively symmetric. The entire length of the insert surface seemed to be covered with fibrous crystal growth which covered the surface very densely and extended into the insert cavity. The farther the distance upstream from the orifice, the less apparent the growth appeared, until the insert surface had a smooth appearance. However, at the upstream end of insert, the crystal formations increased in density symmetrically over the surface. Material was deposited on the surface of molybdenum collar parallel to the tube wall. There was a extensive

Dental putty impressions of the post-test condition of cathode WT-II and the pre- and post-test conditions of the thruster life-test cathodes examined via a shadowgraph. For WT-II, the impression revealed that the orifice diameter and the angle of the chamfer had not changed from the fabrication specifications over the course of the wear-test. For cathode TL-II, the impression verified that the 45° chamfer on the downstream side of the orifice has been eliminated, apparently filled in by material deposition. However, the diameter of the orifice had not changed size greatly, closing down from 0.15 cm to 0.14 cm. The impression confirmed that the orifice of cathode TL-II had been plugged during the life-test.

Figure 41. SE image of tungsten plug from cathode TL-II.

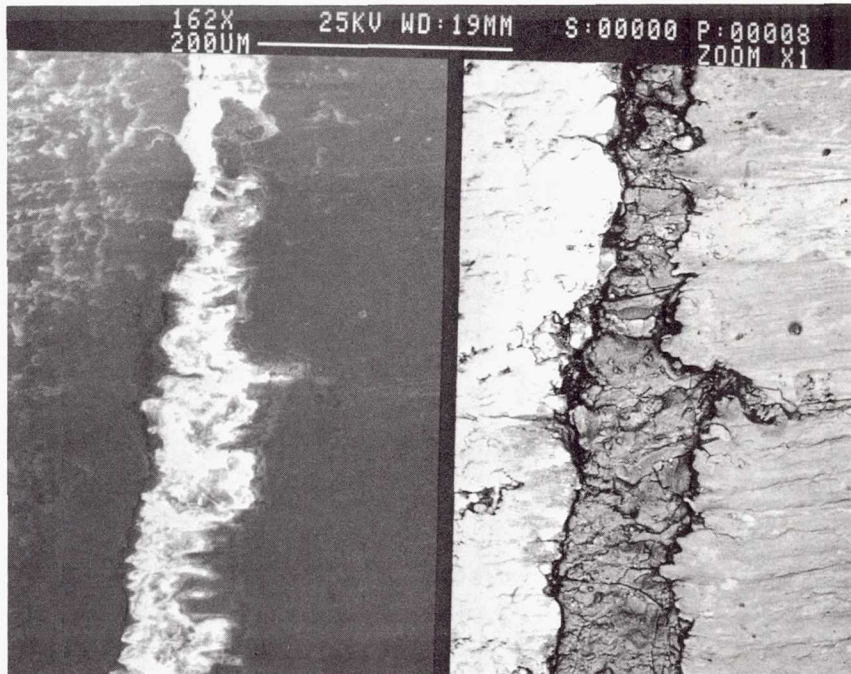
Figure 43. Gap material found between insert and cathode body tube walls in cathode TL-II.
